# Silver Diamine Fluoride 38% - Background

# Silver Diamine Fluoride 38% - Clinical Uses

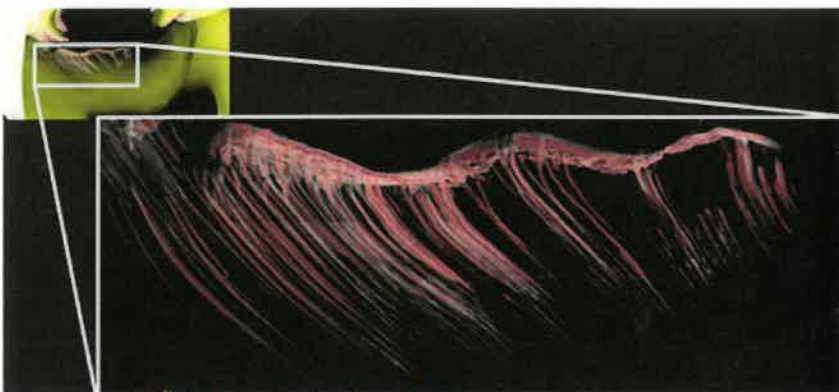
## Micro-CT Scan of Dentinal Penetration of Silver

Silver diamine fluoride 38% is being used for protection on high risk sites. Silver penetrates into and remains on the surface of healthy dentin and/or enamel, providing antimicrobial biofilm resistance. This is particularly valuable in furcations, food traps, root surfaces and newly erupted occlusal surfaces difficult to dry and isolate for sealants.

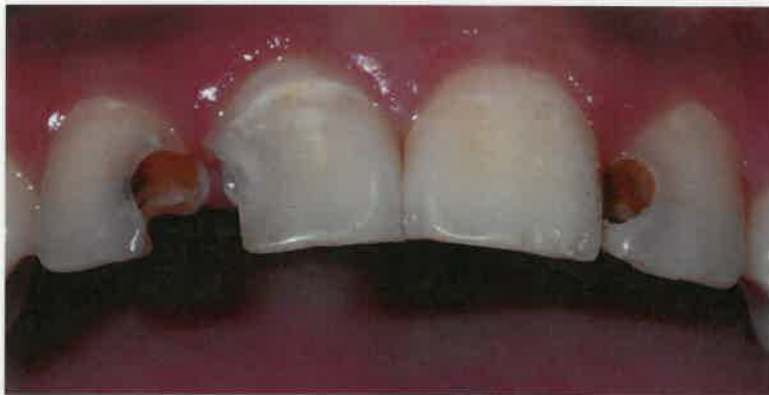
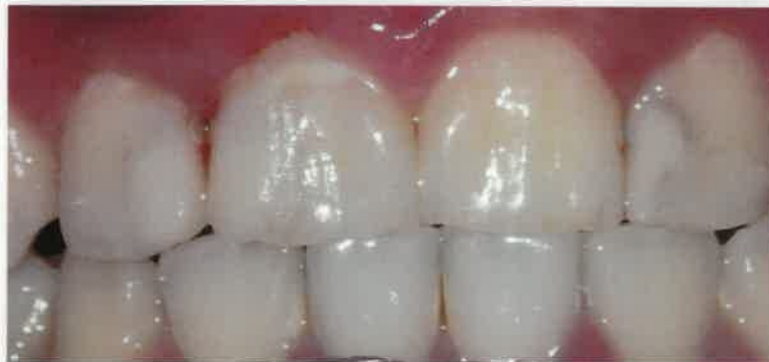
The before/after sets of images show teeth treated with silver diamine fluoride and then covered with glass ionomer restorative material. Glass ionomer materials can be placed in minutes without the need for drills, adhesives or instruments. These SMART restorations may provide a sufficient cover-up for many cases.

Intra- and post-operative SMART #7, 8 & 10, showing clean perimeters and final GIC restorations. Note: tooth #10 had complete stain removal on internal margin.

In situations where esthetics are paramount, dentists apply SDF and then cover the discoloration by polishing and applying composite materials. Another option, especially for permanent dentition, is to polish away discoloration along the margins, then cover the remaining discoloration with a "sandwich" of opaque glass ionomer followed by a composite material.

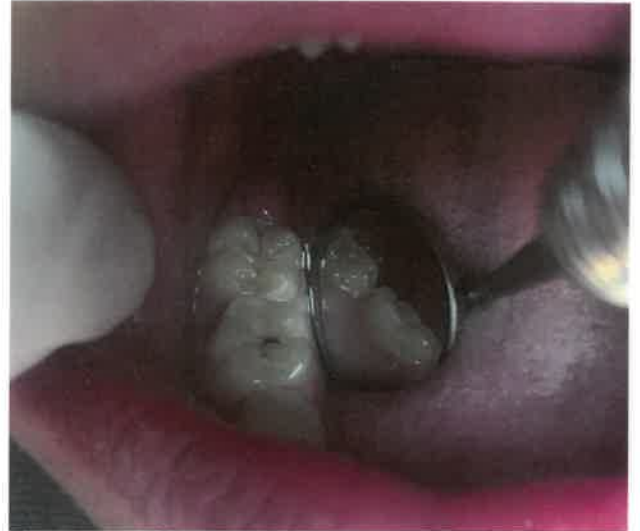
The dark spot on the small arrested lesion on the second molar of this young child may not need any type of restoration.
